# Manhole Inspection Summary

Manhole # S35AA1037MH

**Location** Address: **300 BIRKWOOD PL** Cross Street: **UNIVERSITY PL**

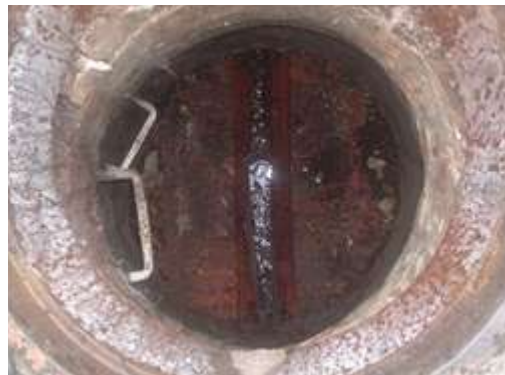
Top View

Evidence of surcharge - Bench debris. Channel debris.

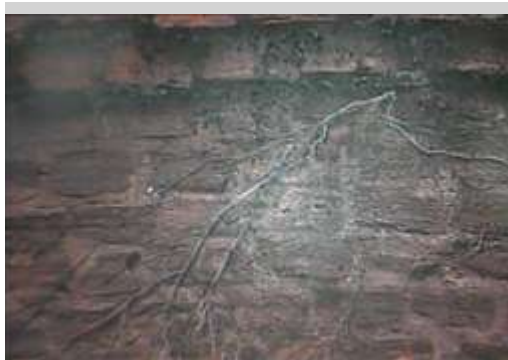
Defect

**Barrel** Material: **Brick** ☐ Parged  
Shape: **Circular** Diameter: **46** (in.) Length: (in.)  
Condition: ☐ Sound ☐ Cracked ☒ **Root Intrusion** ☐ Loose Brick ☐ Deteriorated  
Infiltration: ☐ None ☐ Joint ☐ Cracks ☐ Mortar ☒ **Roots** ☒ **Wall**

Barrel root intrusion and infiltration.

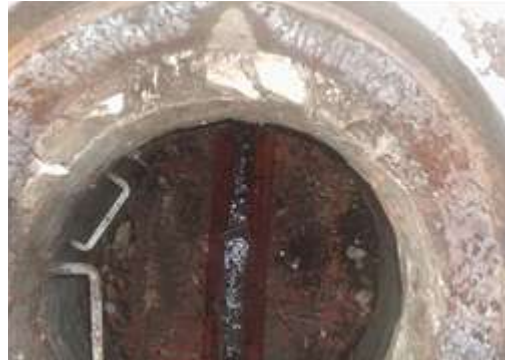
Defect

**Frame** Offset: **3** (in.) Condition: ☒ Sound ☐ Cracked ☐ Leaks

Frame offset. Adjustment deterioration and infiltration. Barrel infiltration.

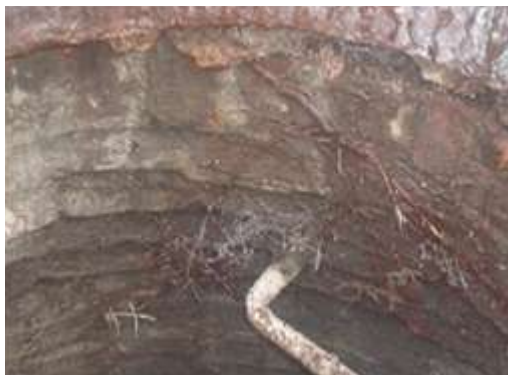
Defect

**Chimney / Frame Adjustment** ☒ Exists Material: **Brick** ☐ Parged Height: **6** (in.)  
Condition: ☐ Sound ☐ Cracked ☒ **Root Intrusion** ☐ Loose Brick ☒ **Deteriorated**  
Infiltration: ☐ None ☒ **Joint** ☐ Cracks ☐ Mortar ☒ **Roots** ☒ **Wall**

**Corbel** Material: **Brick** ☐ Parged Type: **Concentric/Eccentric**  
Condition: ☐ Sound ☐ Cracked ☒ **Root Intrusion** ☐ Loose Brick ☐ Deteriorated  
Infiltration: ☐ None ☐ Joint ☐ Cracks ☐ Mortar ☒ **Roots** ☒ **Wall**

Adjustment deterioration, root intrusion and infiltration. Corbel root intrusion and infiltration.

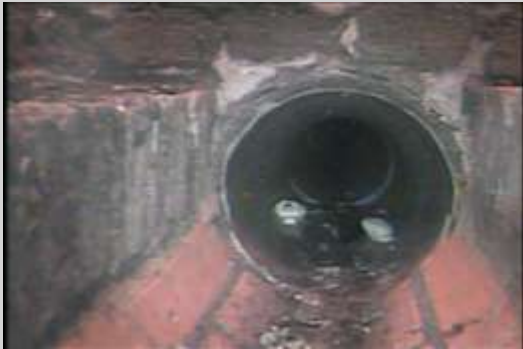
### 8 in. Circular Gravity Sewer Pipe Out @ 12 O'Clock

Deposits: ☐ None ☒ **Mud** ☐ Sludge ☒ **Debris** ☐ Grease

Infiltration: **Evidence** Pipe Seal Cond: **Unknown**

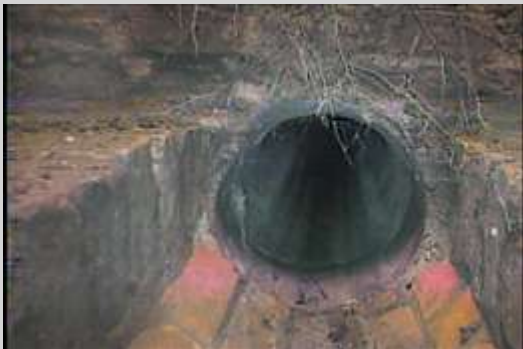
### 8 in. Circular Gravity Sewer Pipe In @ 6 O'Clock

Infiltration: **Evidence** Pipe Seal Cond: **Roots**
